ANNUAL REPORT FOR 2006

Marks Creek Mitigation Site
Wake County
TIP No. R-2547 WM

Prepared By:
Natural Environment Unit & Roadside Environmental Unit
North Carolina Department of Transportation
December 2006

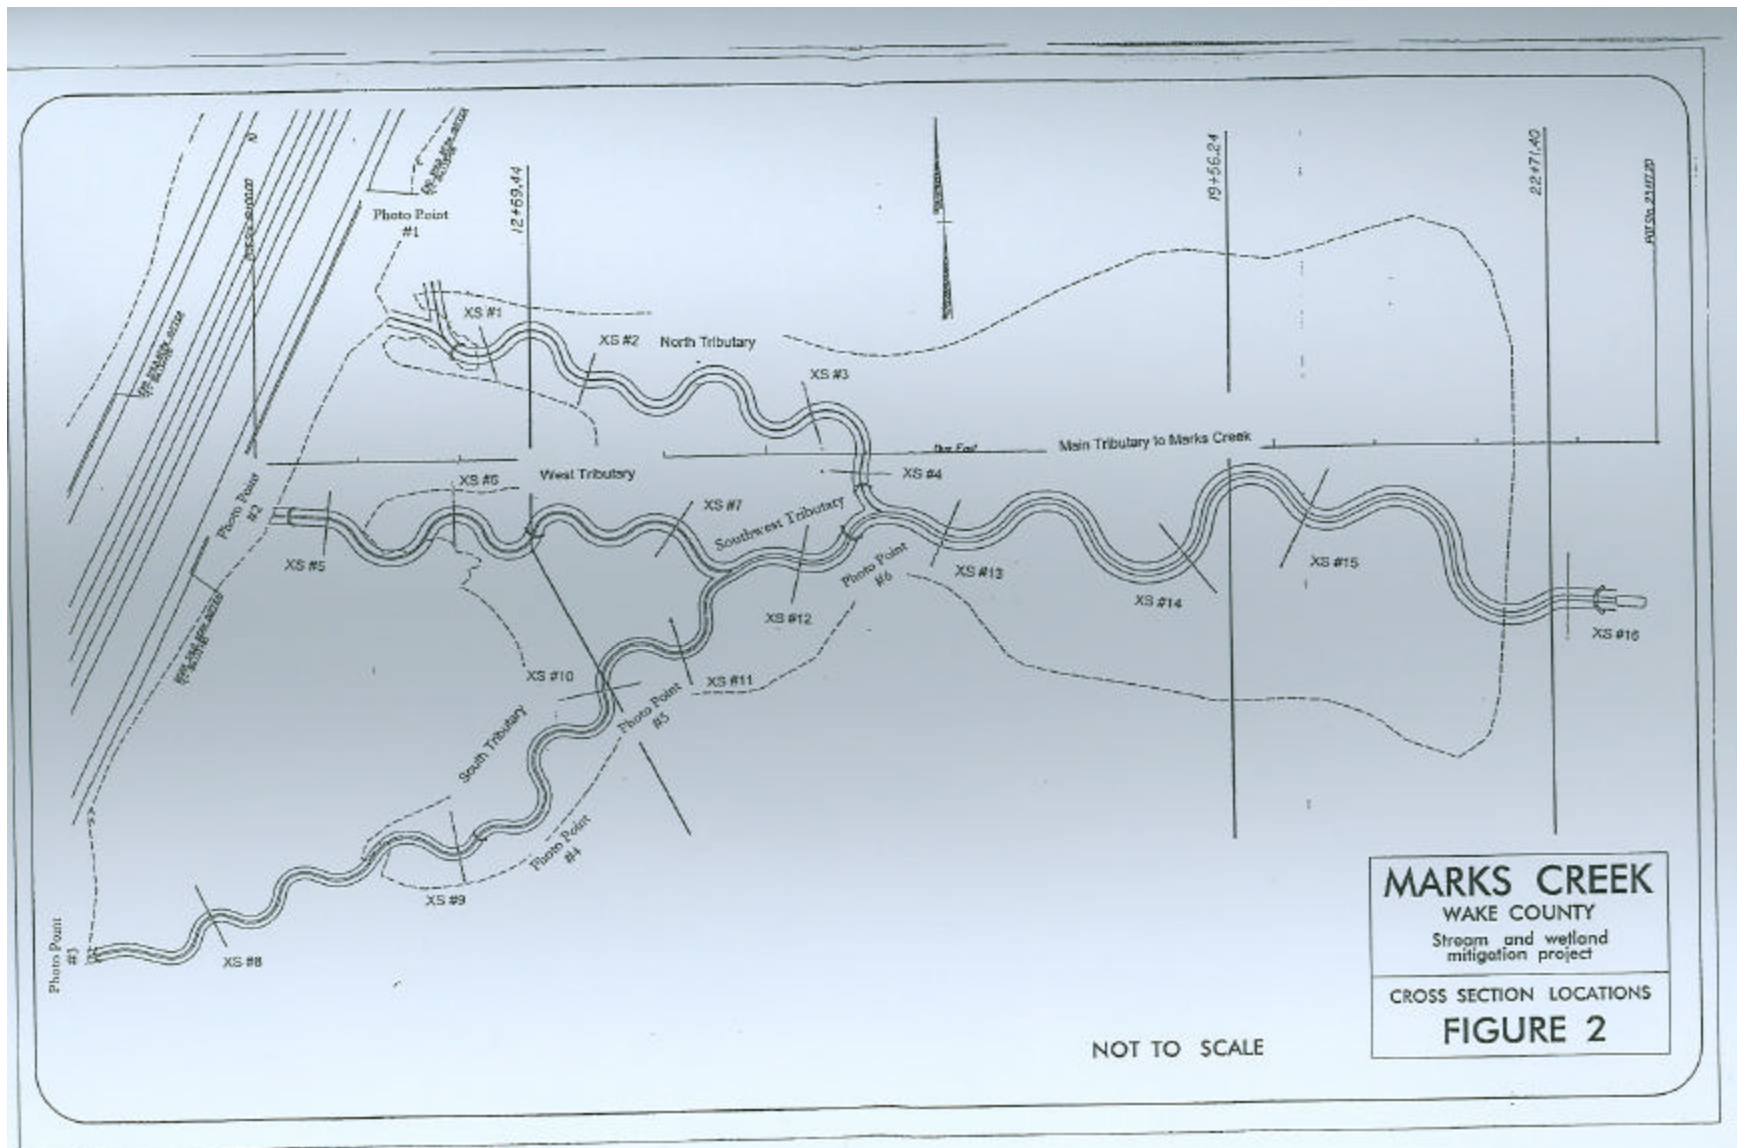
The tributaries to Marks Creek were designed to be classified as C5 stream type channels according to the Rosgen Classification of Natural Rivers; however only the South Tributary classifies as C5, the remaining tributaries classify as a C4 stream type. A total of sixteen cross sections (four along the Main Tributary to Marks Creek and 12 along its four tributaries) were surveyed. For this report, only cross sections containing riffles were used in the comparison of channel morphology presented below in Table 1. Cross section locations are provided on Figure 2.

The sixteen cross sections were established during the 2004 monitoring survey are being monitored on a yearly basis to determine the actual extent of aggradation or degradation. All of the cross section locations appeared stable when compared to the previous years monitoring data. Morphological comparisons are presented in the charts depicted below. Appendix A depicts each cross section comparison as well as a summarized table of morphological variables.

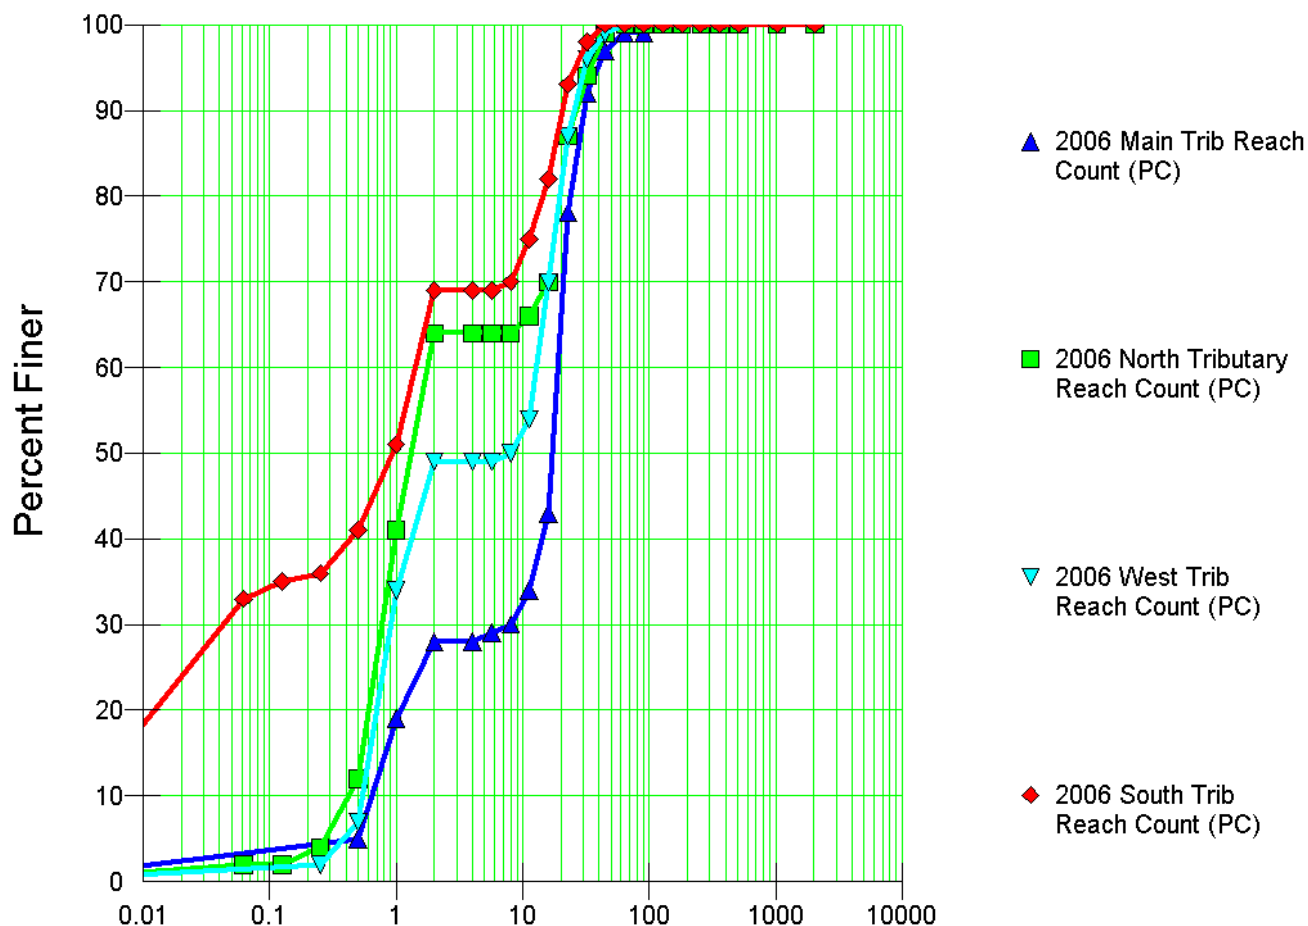
2006 Marks Creek Particle Size Distribution

Pebble counts were taken along each tributary as a means to determine the extent of change in bed material during the monitoring period. The pebble counts taken during the Year 2006 monitoring period classified the stream as a gravel/sand bed system.

Particle Sizes	North Trib	West Trib	South Trib	Main Trib
D16 (mm)	0.57	0.67	0.03	0.89
D35 (mm)	0.90	1.07	0.13	11.82
D50 (mm)	1.39	8.0	0.95	17.32
D84 (mm)	21.44	21.44	17.2	26.63
D95 (mm)	34.6	30.96	26.36	39.8

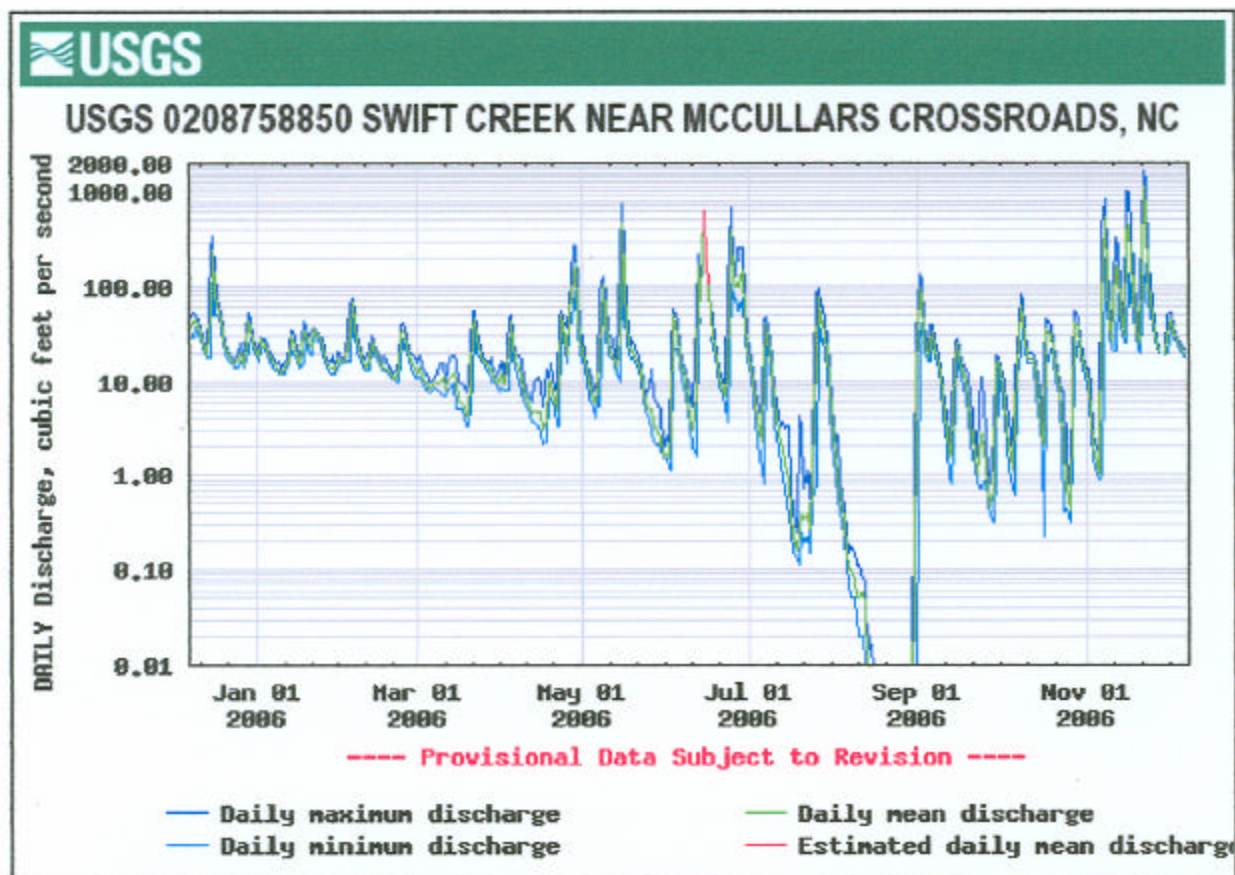
Monitoring requirements state that at least two bankfull events must be documented through the five-year monitoring period. No surface water gages exist along Marks Creek or its tributaries. A review of known USGS surface water gages identified one rural stream gage station within fifteen miles of the mitigation site. This gage station is identified as Swift Creek near McCullars Crossroads. The Swift Creek gage station has a drainage area of 35.8 square miles and is located approximately 15 miles southeast of the mitigation site near the confluence of Swift Creek and Lake Wheeler. The Swift Creek gage accurately reflects the hydrology and precipitation in the project area. It is situated in the USGS Hydrologic Unit 03020201. Datum of the gage is 251.46 feet above sea level NGVD29. Based on the drainage area associated with the gage, the correlated bankfull discharge according to the NC Rural Piedmont Regional Curves (USACE, 2003) is between 770 and 1,760 cubic feet per second (cfs). Following Year 2004 monitoring activities, a review of peak flows was conducted for the period between July 2002 and July 2004. According to USGS data, Marks Creek met its requirement of two bankfull events during the first year of monitoring, with both of the events happening in 2003. Reviews were also conducted for 2006. The USGS graph presented below indicates that six bankfull events occurred in 2006.

Based on information obtained from the USGS, the Marks Creek Site has met the required monitoring protocols for hydrology as it relates to bankfull events that have occurred on site since the time of construction.
